Operational Environmental Management Plan (OEMP)

238-258 Captain Cook Drive, Kurnell NSW

Prepared for Dicker Data Limited

Report No: 19074RP05

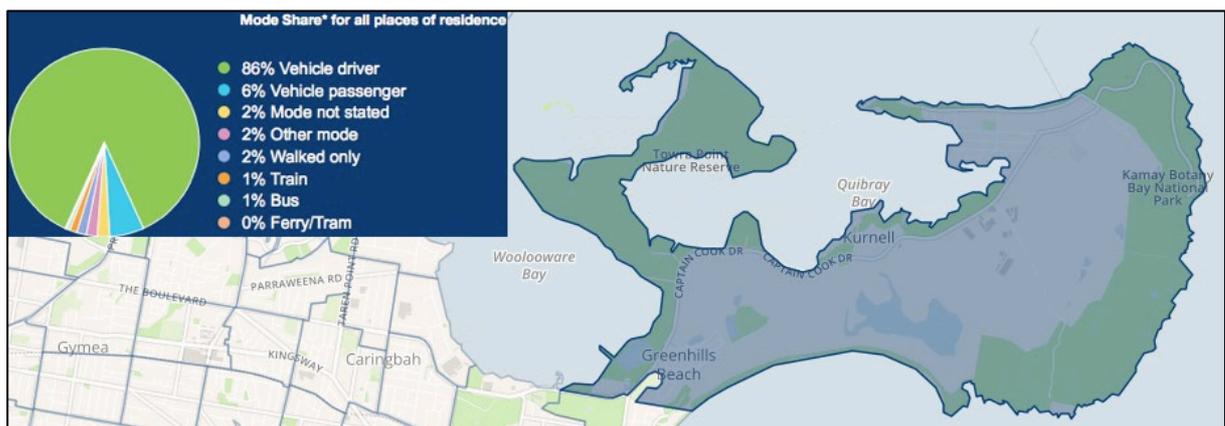
Figure 2: Journey to Work Mode Share - 2011

The modal share data shows that a majority of the commuter trips are undertaken as a vehicle driver (86%) with approximately 6% of commuter trips undertaken by as a vehicle passenger.

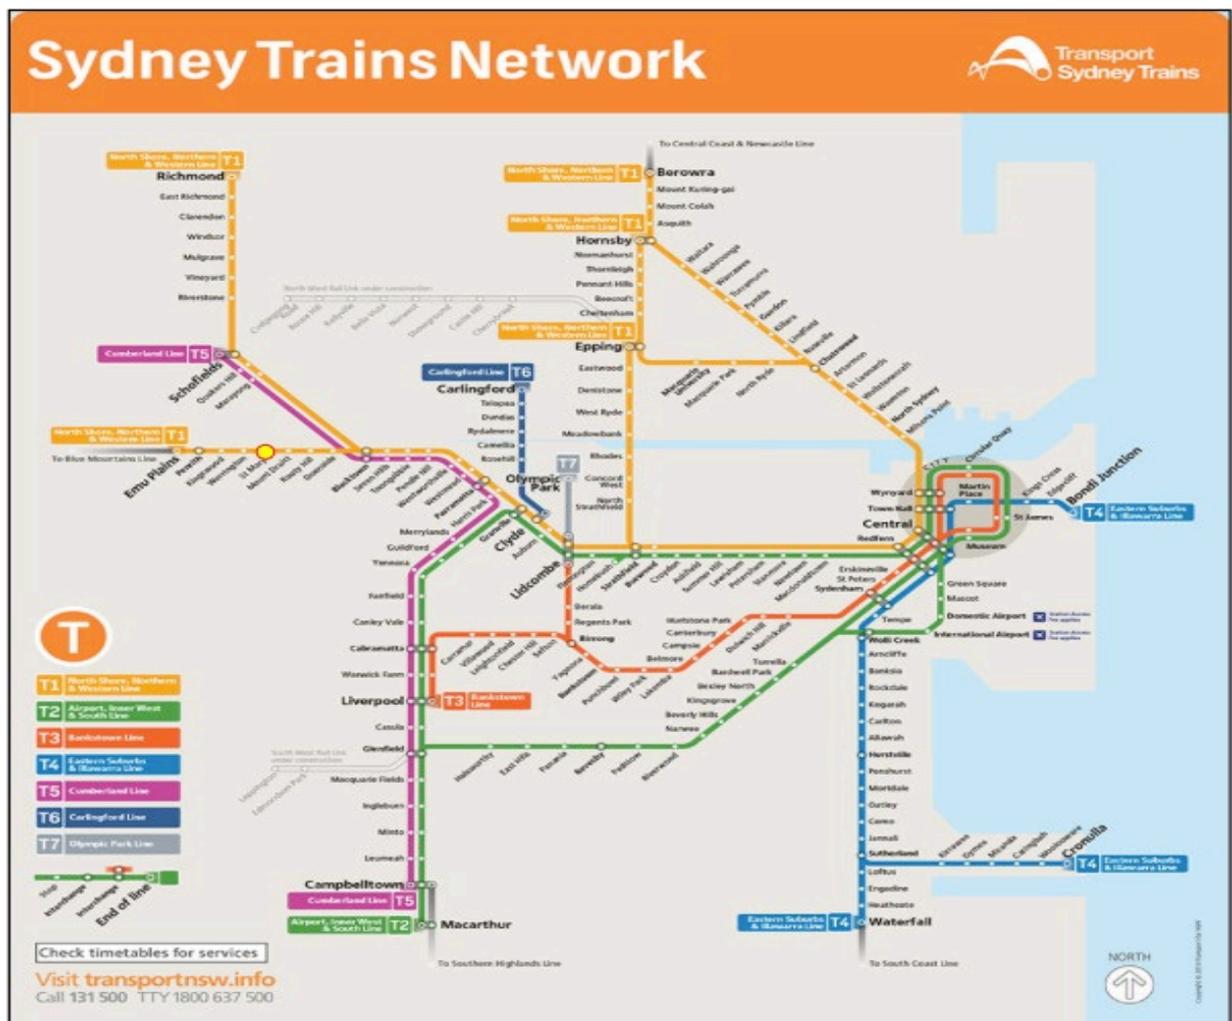
Figure 4: Suburban Rail Network

The above table indicates that Cronulla railway station is well serviced in peak periods with trains arriving approximately every 10 minutes to and from the City. **Figure 4** showcases Cronulla Station, located at end of the T4 Eastern Suburbs and Illawarra Line, in relation with the rest of the Sydney Trains Network.

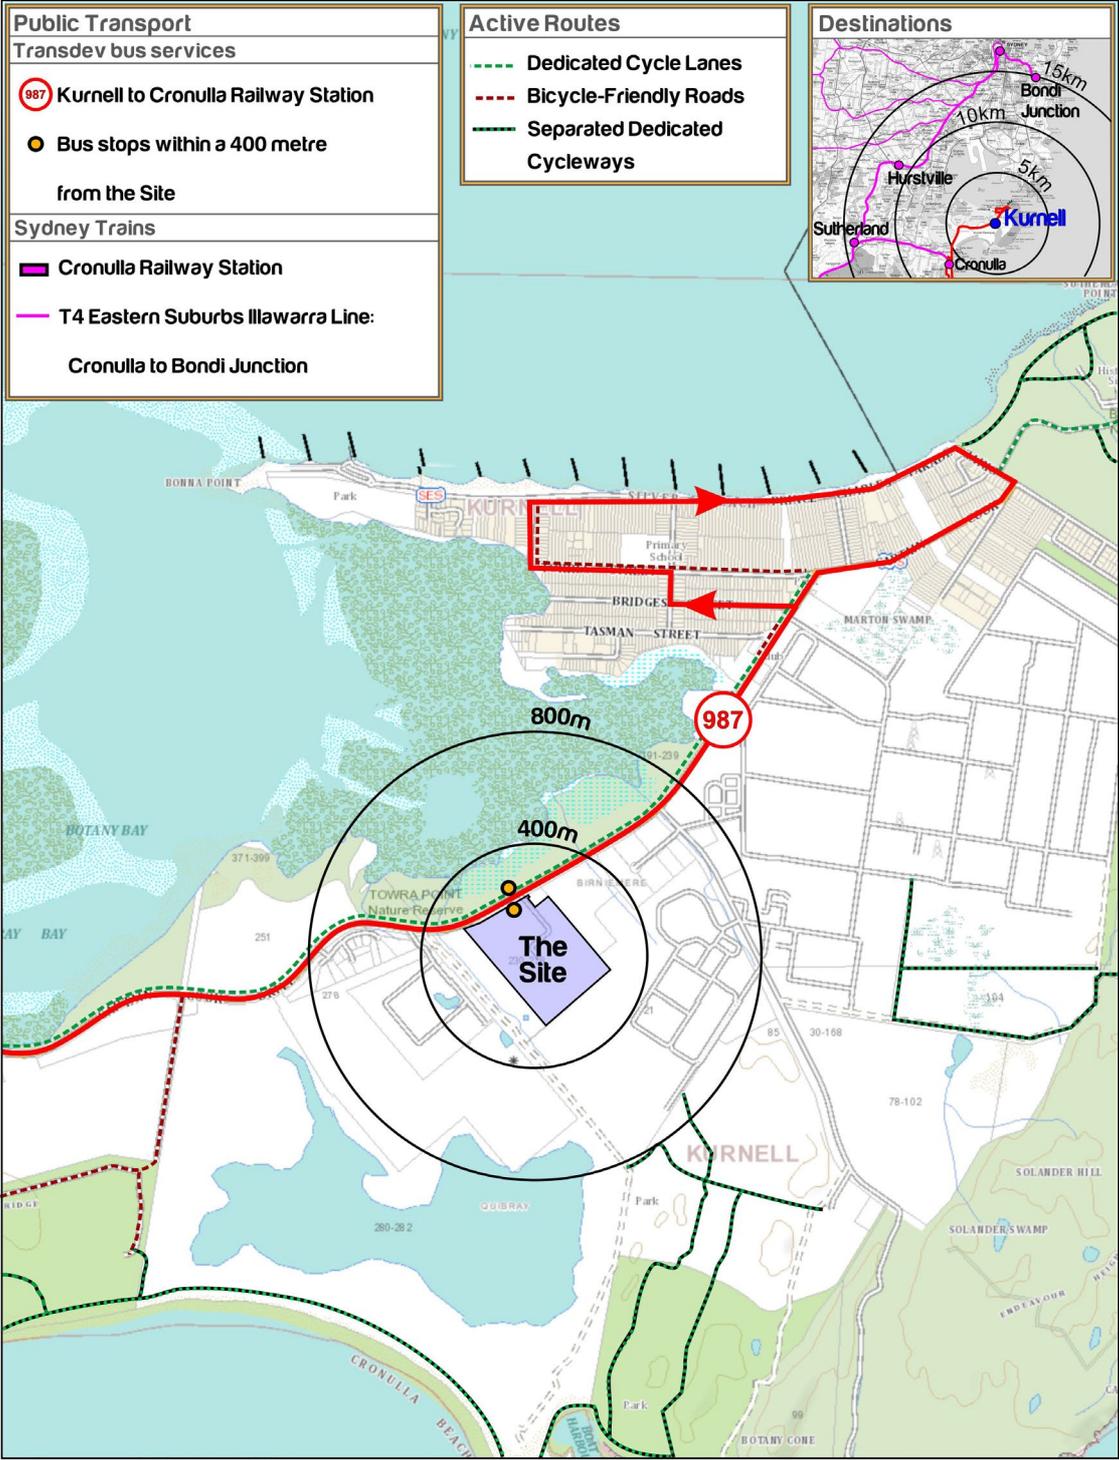
Figure 5: Public Transport Network

- Bus service 987 which provides connections between Kurnell and Cronulla Station with approximately 30 minutes interval during the peak hours and hourly frequencies throughout the day.

Bus stops for this route are available directly on the Site's street frontage of Captain Cook Drive.

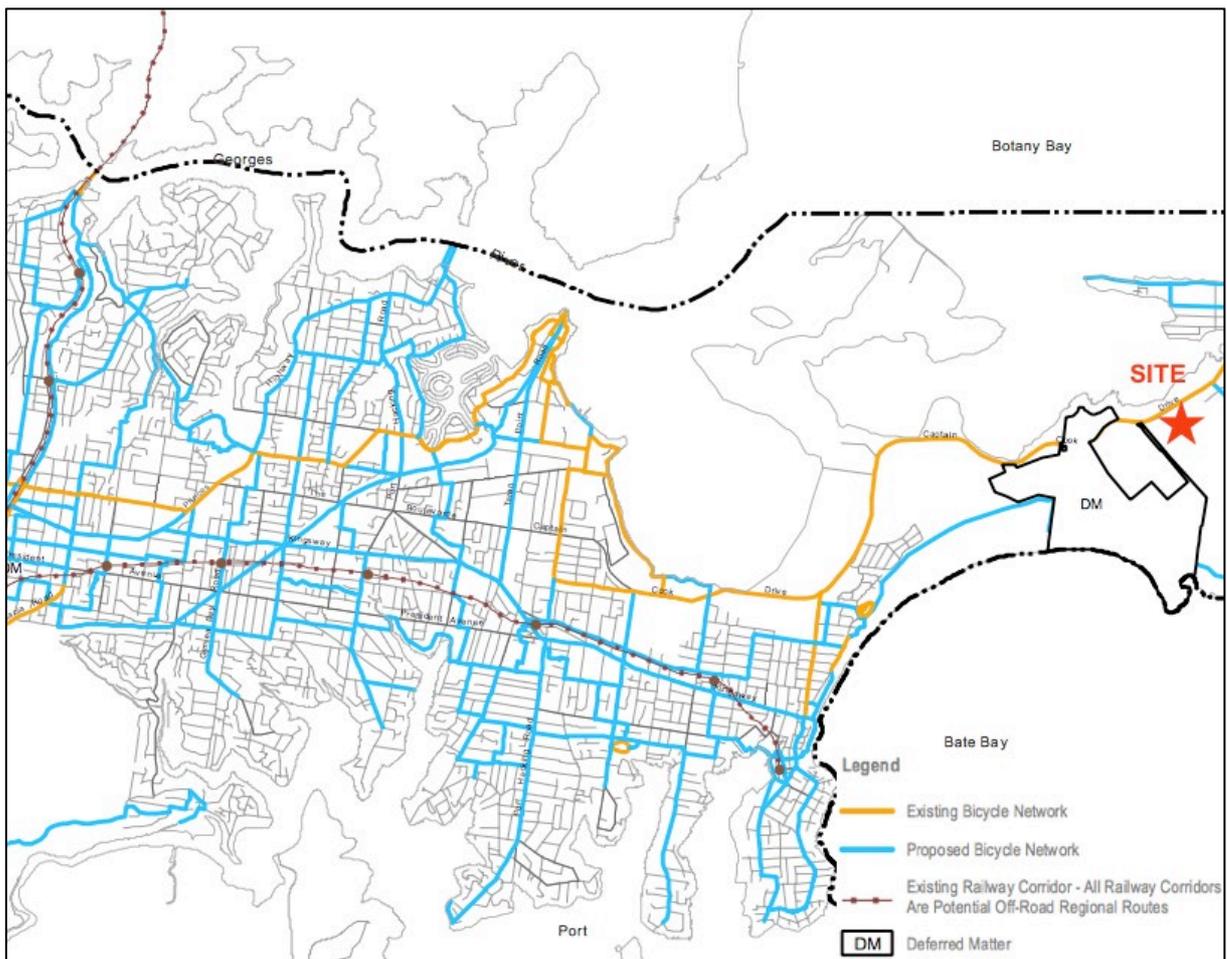
Figure 6: Existing Public Transport Map

Although the Site does not have any pedestrian accessibility via pedestrian footpaths in its vicinity, Captain Cook Drive has dedicated bicycle lanes in both directions on either side of the road. This bicycle route connects with the rest of Sutherland Shire’s extensive bicycle path network. Additional bicycle paths have been planned by Council to extend the bicycle network’s accessibility for the Sutherland Shire area. Reference to **Figure 6** demonstrates the Site’s accessibility to the bicycle network.

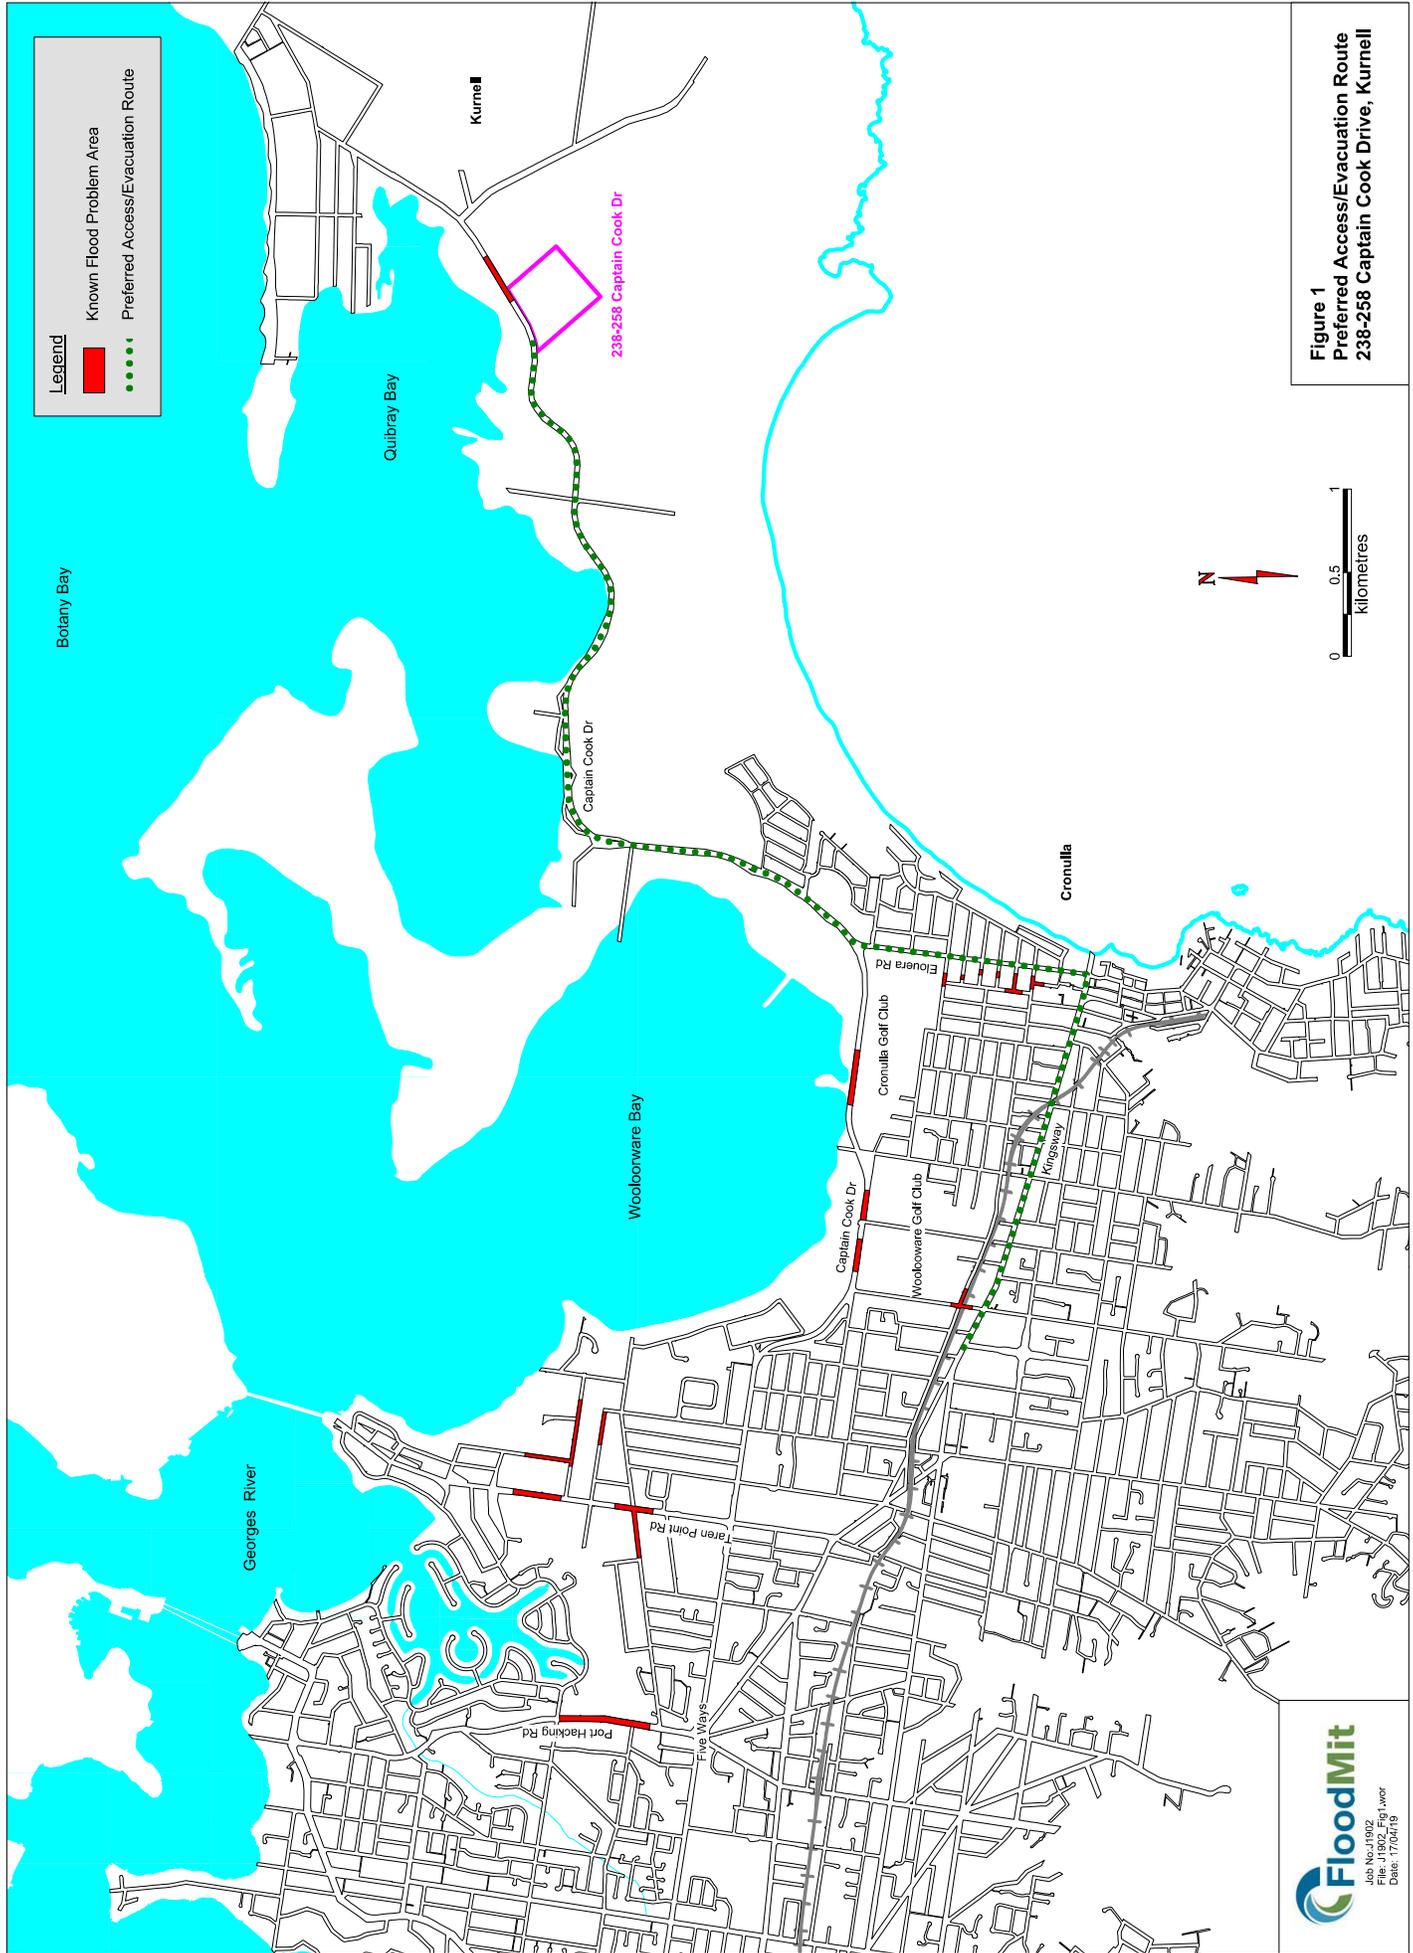
Figure 1
Preferred Access/Evacuation Route
238-258 Captain Cook Drive, Kurnell

Attachments
Figure 1 – Preferred Access/Evacuation Route

Onsite flooding occurs when the intensity of rainfall exceeds the capacity of the stormwater drainage network. This will typically occur during intense, short duration, thunderstorm conditions. Flooding will mostly be shallow (less than 0.3m in depth) across the site, except in the water quality ponds and stormwater channel where deeper inundation depths will be experienced. Captain Cook Drive may be overtopped near the main (eastern) entrance to the site. There is no risk of flooding to the office and factory.
